GREEN & ENERGY AUDIT REPORT of Kalinga Institute of Industrial Technology (KIIT, Deemed to be University U/S 3 of UGC Act 1956)

ENER VISION
(ISO 9001 CERTIFIED & BEE
empaneled ESCO)
Kandivali EAST, MUMBAI

ENERGY AUDIT REPORT:

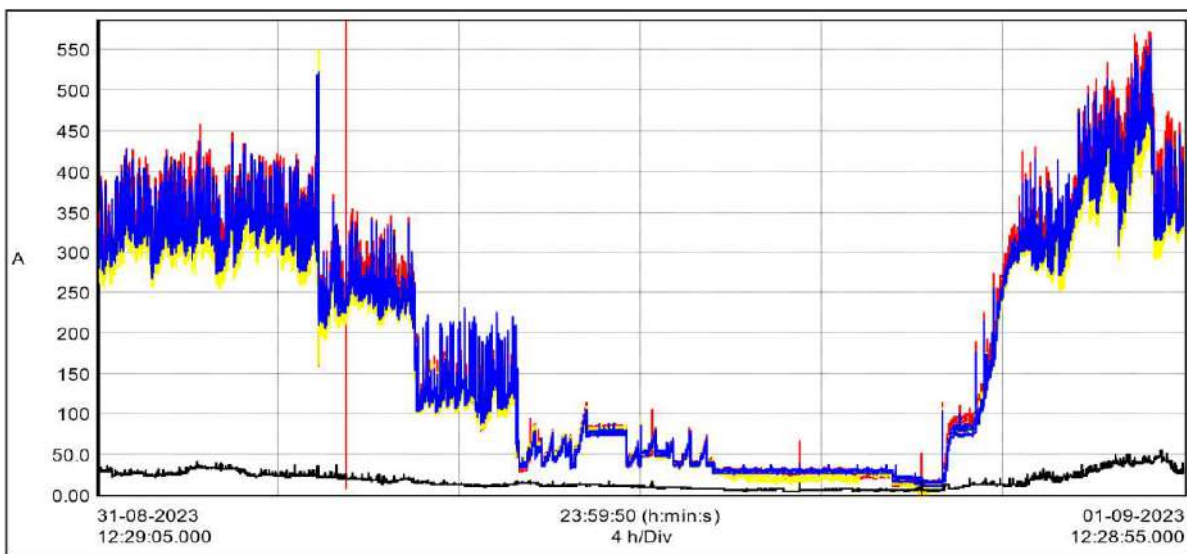
A_{rms} –

Name	Date	Time	Avg	Min	Max	Units	Duration	Units
A1 rms	31-08-2023	12:29 PM	238.30	0.00	701.50	A	23:59:55	(h:min:s)
A2 rms	31-08-2023	12:29 PM	216.97	0.00	551.00	A	23:59:55	(h:min:s)
A3 rms	31-08-2023	12:29 PM	227.61	12.00	564.50	A	23:59:55	(h:min:s)
AN rms	31-08-2023	12:29 PM	20.97	4.77	56.09	A	23:59:55	(h:min:s)

Remarks: Load is distributed uniformly in all the phases.

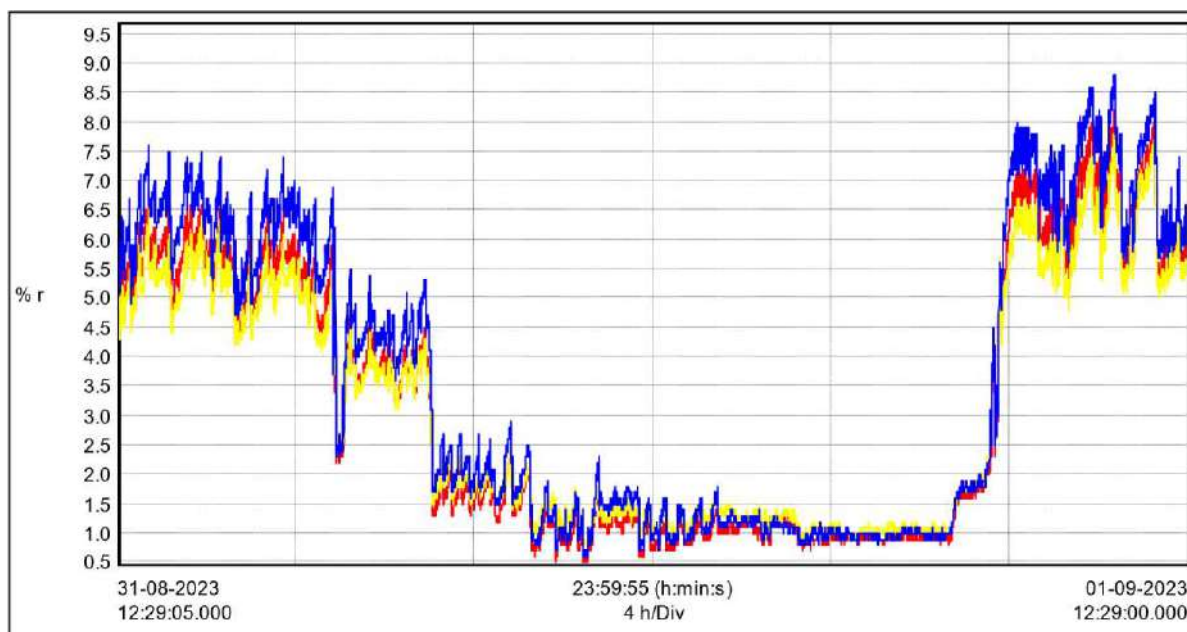
VThdr:

Name	Date	Time	Avg	Min	Max	Units	Duration	Units
V1 THDr	31-08-2023	12:29 PM	3.242	0.5	8.2	% r	23:59:55	(h:min:s)
V2 THDr	31-08-2023	12:29 PM	3.183	0.8	7.8	% r	23:59:55	(h:min:s)
V3 THDr	31-08-2023	12:29 PM	3.633	0.6	8.8	% r	23:59:55	(h:min:s)

Remarks: Voltage harmonic values are normal and are within the limit.

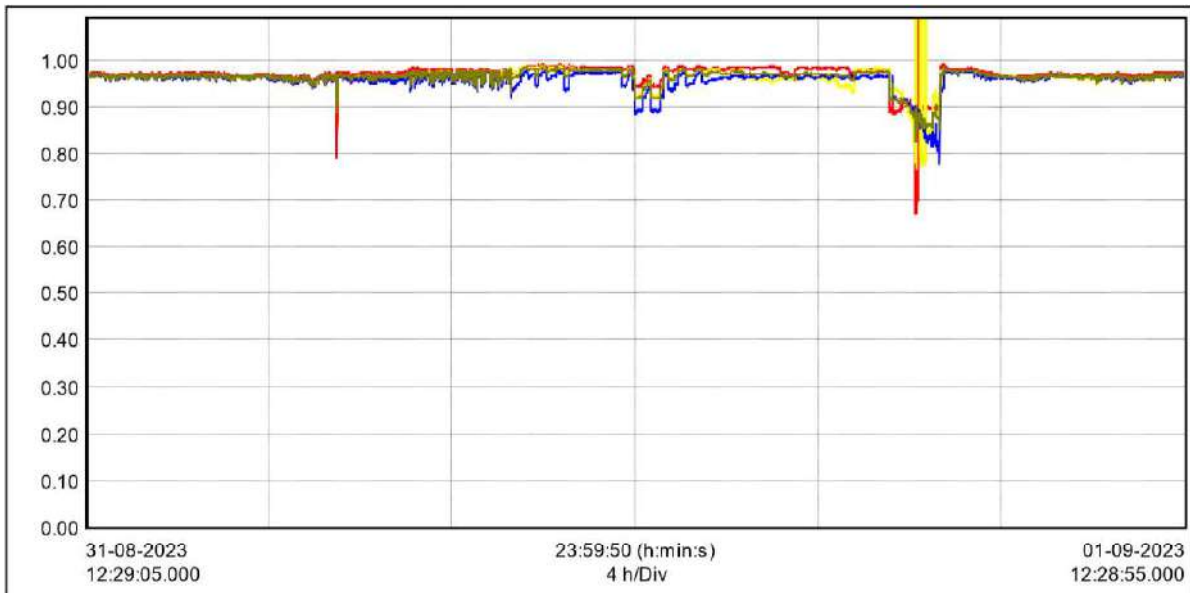
Power Factor:

Name	Date	Time	Avg	Min	Max	Duration	Units
PF1	31-08-2023	12:29 PM	0.97	0.67	0.99	23:59:55	(h:min:s)
PF2	31-08-2023	12:29 PM	0.96	0.77	0.99	23:59:55	(h:min:s)
PF3	31-08-2023	12:29 PM	0.96	0.78	0.98	23:59:55	(h:min:s)
PFT	31-08-2023	12:29 PM	0.96	0.83	0.99	23:59:55	(h:min:s)

Remarks: Avg Power factor values are good.

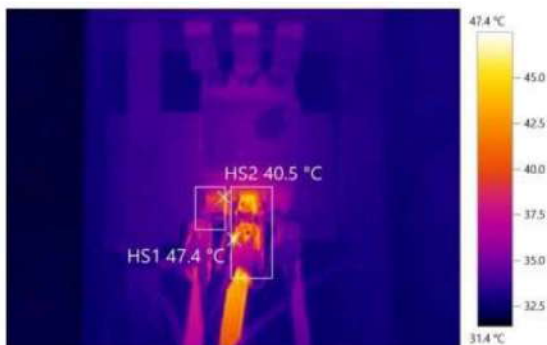
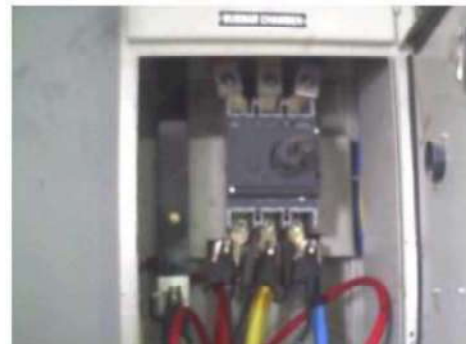
AC panel-1 main incomer:

Picture data:	Date:	04-09-2023	Emissivity:	0.88
	Time:	15:17:03	Refl. temp. [°C]:	19.0
	File:	IV_23511.BMT

Measurement Objects	Temp. [°C]	Emiss.	Refl. temp. [°C]	Remarks
Hot spot 1	47.4	0.88	19.0	Temperature found in Y phase.
Hot spot 2	40.5	0.88	19.0	Temperature found in R phase.

Remarks: temperature now is normal but may increase in future. Need to do the relogging and crimping properly.

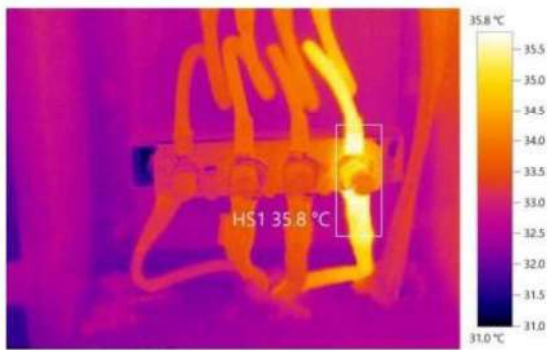
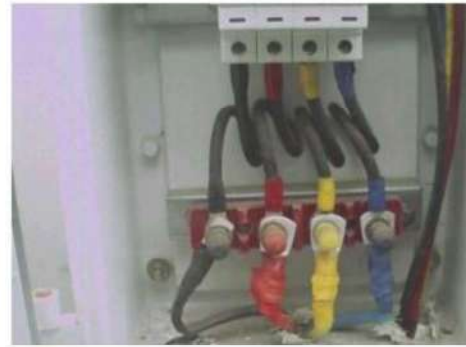
C 5th AC outdoor terrace MCB:

Picture data: Date: 04-09-2023 Emissivity: 0.88
 Time: 14:49:33 Refl. temp. [°C]: 19.0
 File: IV_23488.BMT

Measurement Objects	Temp. [°C]	Emiss.	Refl. temp. [°C]	Remarks
Hot spot 1	35.8	0.88	19.0	Temperature found in B phase.

Remarks: temperature now is normal but may increase in future. Need to do the relogging and crimping properly

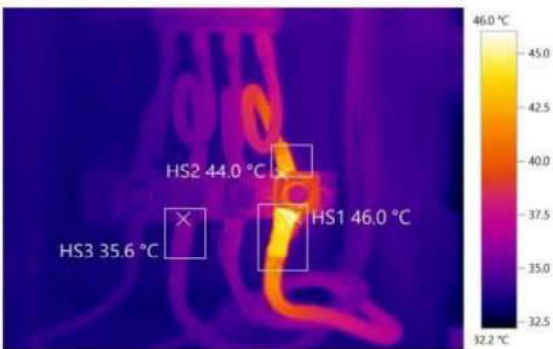
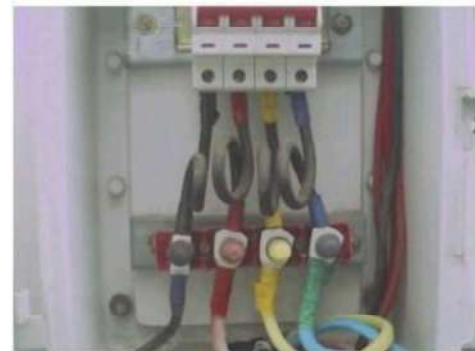
B 3rd AC Outdoor terrace MCB:

Picture data: Date: 04-09-2023 Emissivity: 0.88
 Time: 14:54:08 Refl. temp. [°C]: 19.0
 File: IV_23503.BMT

Measurement Objects	Temp. [°C]	Emiss.	Refl. temp. [°C]	Remarks
Hot spot 1	46.0	0.88	19.0	Temperature found in B phase.
Hot spot 2	44.0	0.88	19.0	Temperature found in B phase.
Hot spot 3	35.6	0.88	19.0	Temperature found in R phase.

Remarks: temperature now is normal but may increase in future. Need to do the relogging and crimping properly

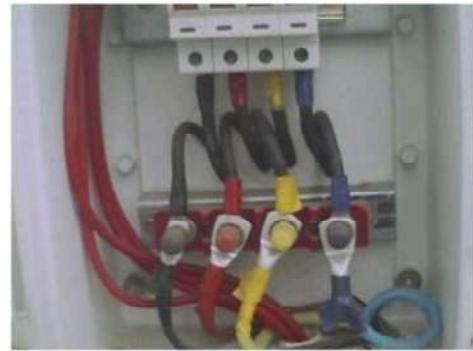
A 3rd AC outdoor MCB terrace:

Picture data: Date: 04-09-2023
Time: 14:55:44
File: IV_23506.BMT

Measurement Objects	Temp. [°C]	Emiss.	Refl. temp. [°C]	Remarks
Hot spot 1	40.7	0.88	19.0	Temperature found in Y phase.
Hot spot 2	38.3	0.88	19.0	Temperature found in B phase.

Remarks: temperature now is normal but may increase in future. Need to do the relogging and crimping properly

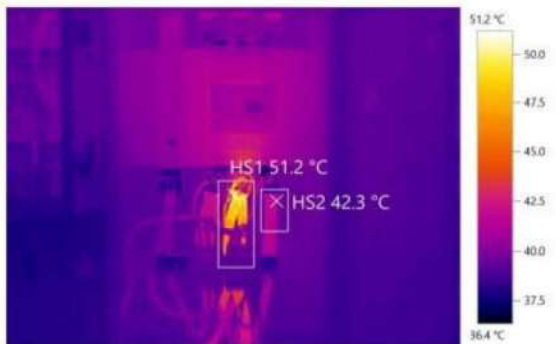
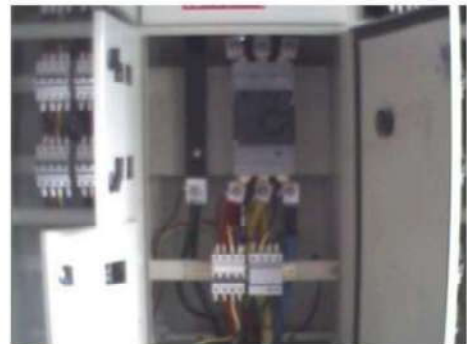
AC panel-2 main incomer:

Picture data: Date: 04-09-2023
Time: 15:25:22
File: IV_23520.BMT

Measurement Objects	Temp. [°C]	Emiss.	Refl. temp. [°C]	Remarks
Hot spot 1	51.2	0.88	19.0	Temperature found in Y phase.
Hot spot 2	42.3	0.88	19.0	Temperature found in B phase.

Remarks: temperature now is normal but may increase in future. Need to do the relogging and crimping properly

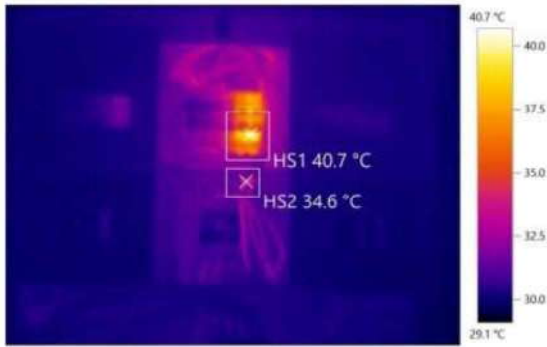
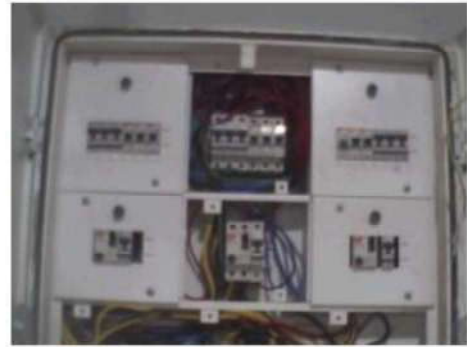
3rd floor LDB:

Picture data: Date: 04-09-2023 Emissivity: 0.88
 Time: 16:02:05 Refl. temp. [°C]: 19.0
 File: IV_23562.BMT

Measurement Objects	Temp. [°C]	Emiss.	Refl. temp. [°C]	Remarks
Hot spot 1	40.7	0.88	19.0	Temperature found at MCB Body.
Hot spot 2	34.6	0.88	19.0	Temperature found in Y phase.

Remarks: temperature now is normal but may increase in future. Increase the MCB rating.

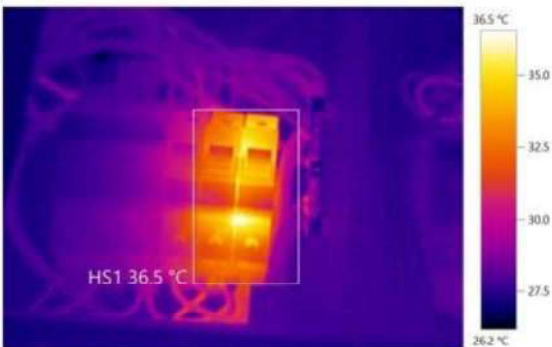
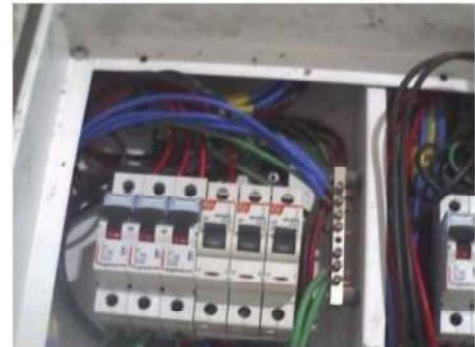
Basement LDB:

Picture data: Date: 04-09-2023 Emissivity: 0.88
 Time: 17:06:29 Refl. temp. [°C]: 19.0
 File: IV_23610.BMT

Measurement Objects	Temp. [°C]	Emiss.	Refl. temp. [°C]	Remarks
Hot spot 1	36.5	0.88	19.0	Temperature found at MCB Body.

Remarks: temperature now is normal but may increase in future. Increase the MCB rating.
